PATIENT INFORMATION SHEET

TYPES OF HIP REPLACEMENTS AND BEARING SURFACES

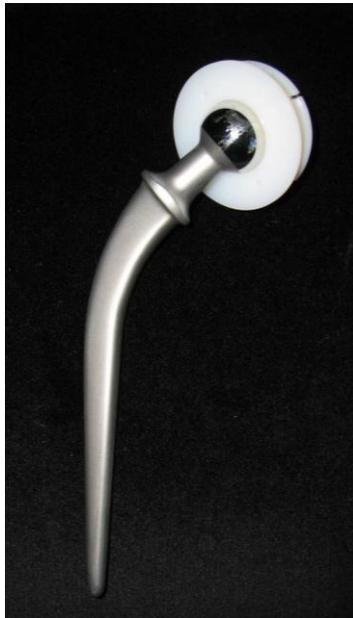
An example of a Cemented hip Replacement

The Metal Stem and Plastic Socket

This is the type of hip replacement that first came into common clinical usage in the 1960s; they are the most tried and tested with the longest clinical results. The arthritic head of the femur (the 'ball' of the hip joint) is removed and replaced by a metal ball that is fixed by means of a stem inserted into the

shaft of the femur. The socket of the hip is lined by a polyethylene cup. Both components are held in place by a plastic cement called polymethyl methacrylate.

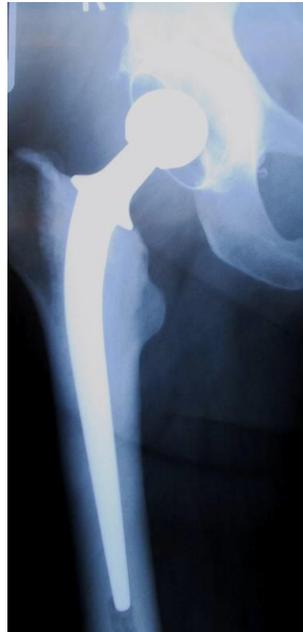
An X-ray showing it in place

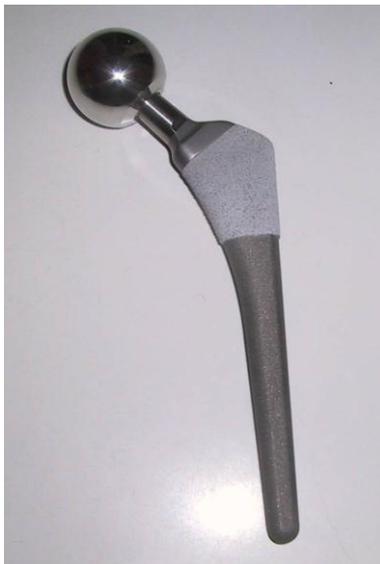
An example of an Uncemented Hip Replacement

The Metal Stem with coating

The design of these replacements is similar to that of cemented replacements with the exception that no cement is used. A special coating is applied to the stem that encourages bone to grow onto the replacement and hold it in place. A metal liner that also has a special coating is used for the socket and a plastic socket fits into this to form the bearing surface.

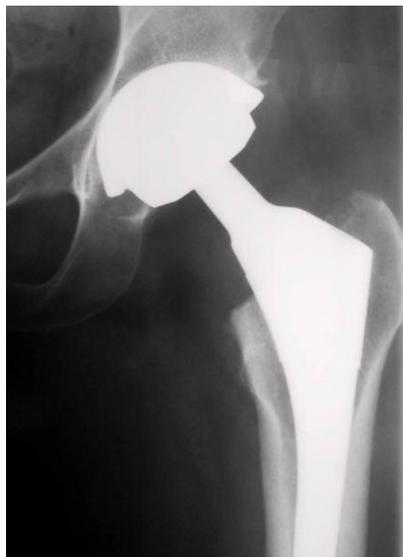
An X-ray showing it in place

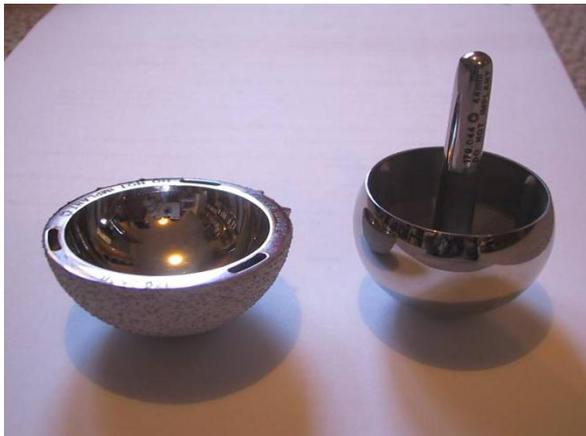
An example of a Hip Resurfacing Replacement

The Metal Socket and Metal Cap

Although the idea for hip resurfacing is not new, the ability to make a successful model is recent. This type of hip replacement uses a metal socket like an uncemented hip replacement socket, but with no plastic liner. Instead of cutting off the femoral head (the 'ball' of the hip) the surface is milled and covered with a metal cap that fits over the head.

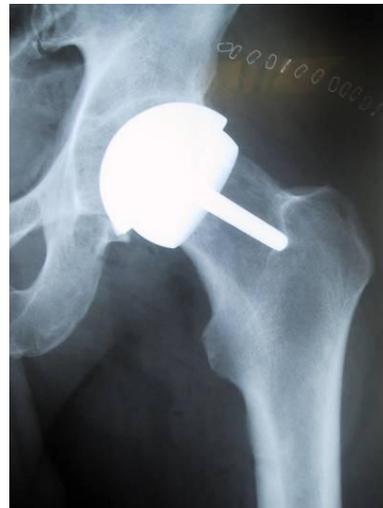
An X-ray showing it in place
